# ***Recent Trends in Fixation of Proximal Humerus Fractures***

**An Essay**

*Submitted for Fulfillment of Master Degree  
In Orthopedic surgery*

**Faculty of Medicine  
Cairo University  
2010**

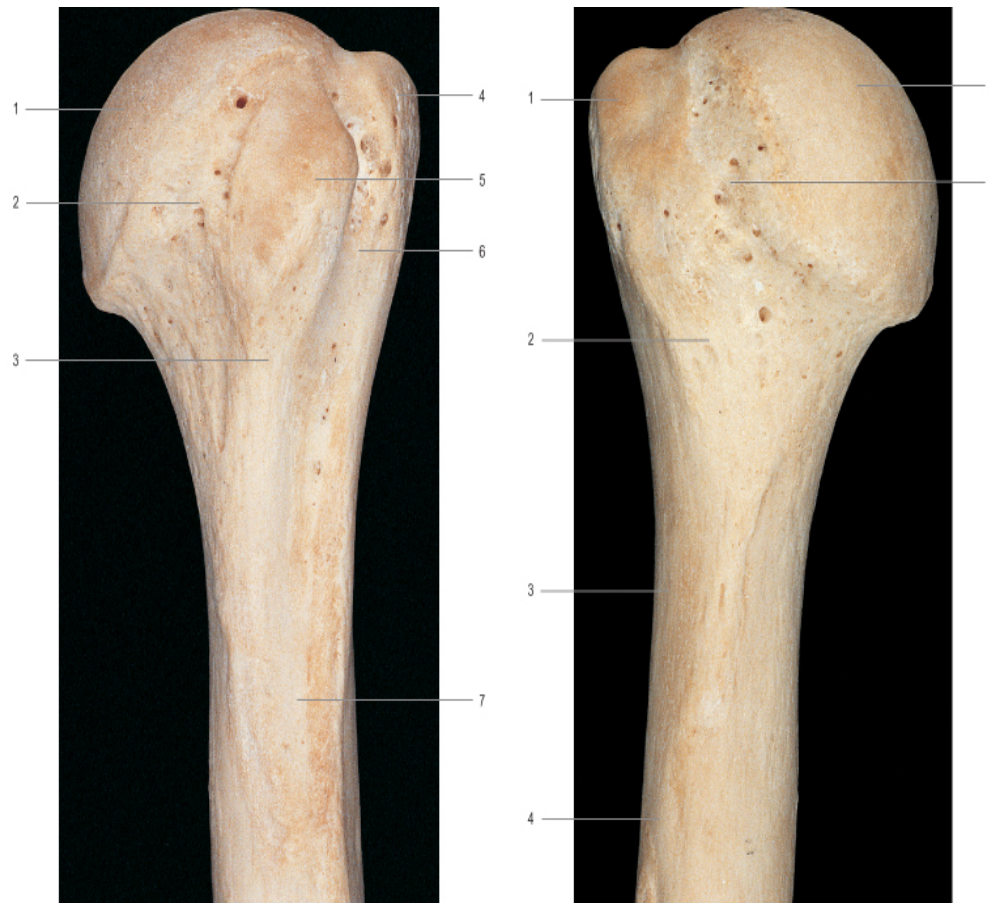
Fig(1)  
Part A: 1. Head. 2. Anatomical neck. 3. Surgical neck. 4. Greater tubercle. 5. Lesser tubercle. 6. Intertuberosus sulcus. 7. Shaft.  
Part B: 1. Greater tubercle. 2. Surgical neck. 3. Shaft. 4. Radial groove. 5. Head. 6. Anatomical neck.

The intertuberosus sulcus (bicipital groove) lies between the tubercles. It contains the long tendon of biceps, its synovial sheath, and an ascending branch from the anterior circumflex humeral artery. the rough lateral lip of the groove is marked by the bilaminar tendon of pectoralis major, its floor by the tendon of latissimusdorsi and its medial lip by the tendon of teres major.fig(1) <sup>[9]</sup>
